# Case Study

## CALIBER™ XR 2

### After nearly 13,000 hours, South African mine finds no measurable wear on loader bucket hinge

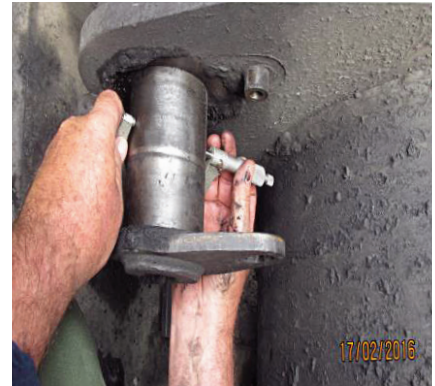
Bucket pin was measured at 3.536 inches (89.82mm).

Pin and bushing were subsequently examined at 10,397 hours and 12,856 hours with no signs of wear or measurable change in dimension.

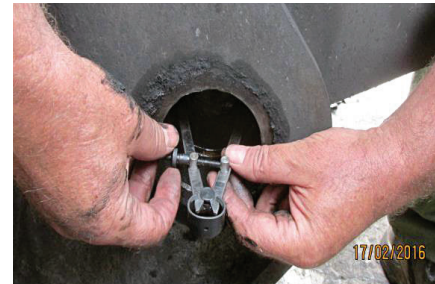
Bucket pin bushing was measured at 3.5555 inches (90.32mm).
